TECH TIPS

Applications:

This bulletin applies to various medium, heavy duty and industrial applications.

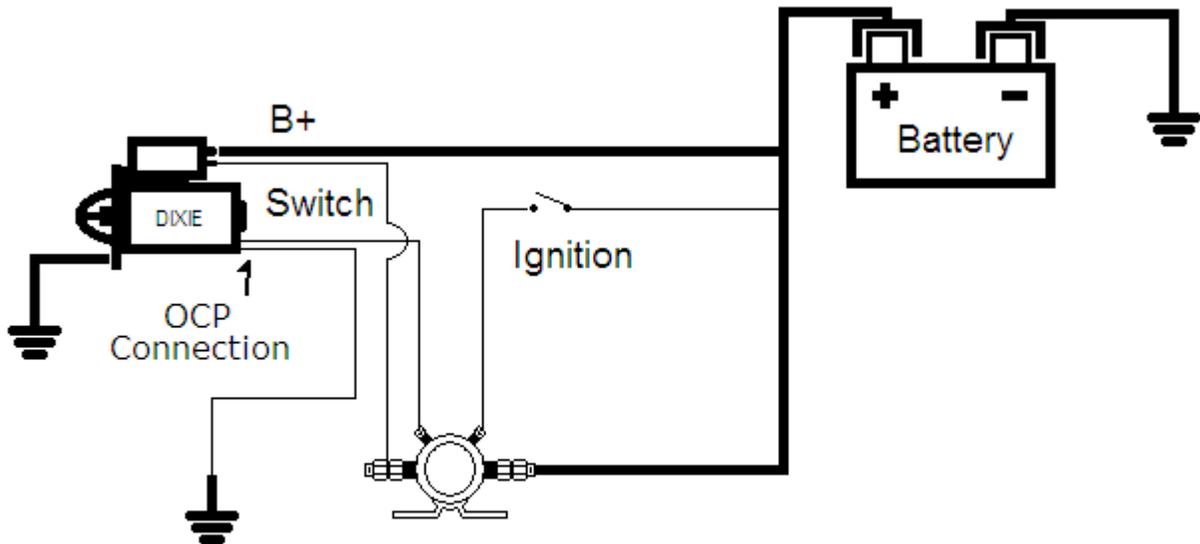
Simplified wiring diagram

The OCP feature will not function if the starter is being used to replace a standard non-OCP starter **unless** there is a relay or magnetic switch added to the system.

Follow the manufacturer's recommended procedure for installing the relay or magnetic switch. Below is a typical wiring configuration for an OCP equipped starter. If no relay or magnetic switch is installed the OCP feature is completely bypassed.
